Transmission Families: Gen 3 Automated

Pre-Authorized Warranty Repair Guideline RWRG0050

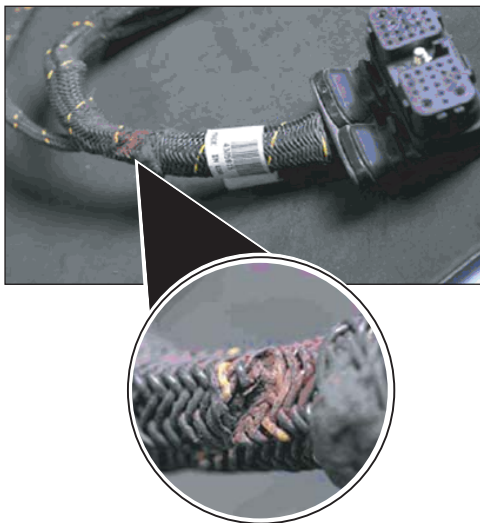
Harness is chaffing on the edge of the harness bracket causing a short.
