Legacy Design Cobra Shifter Failures

Pre-Authorized Warranty Repair Guideline RWRG0064

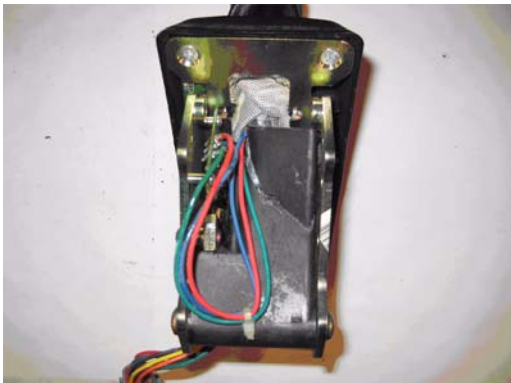
Cracked body inside of shifter

- Crack is located inside the body of shift lever
- Loose lever shaft set screws
- Cracked/broken reed switches

2. Remove 4 ¼-20 fasteners securing Cobra lever to tower/mounting bracket.
3. Discard ¼-20 fasteners.
4. Disconnect the lever harness connector.
5. Remove old Cobra lever.
6. Reconnect lever harness connector to new 430544G. Insert Cobra lever into tower/mounting bracket.
7. Insert Cobra lever into tower/mounting bracket.
8. Line up through holes in tower/mounting bracket to threaded studs in Cobra lever frame.
9. Install and torque the included M6 fasteners to 6-8 lbs. ft.

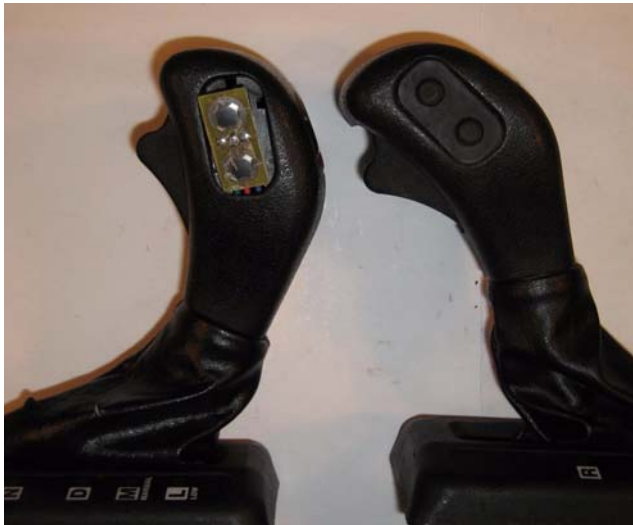
Missing up / down shift buttons
